SPECIAL REPORT

FLOOD OF MARCH 2, 1938, IN REGION 10

SOUTHERN CALIFORNIA

SUBJECT Operation of Flood  
Control Structures, Storm of  
March, 1938.

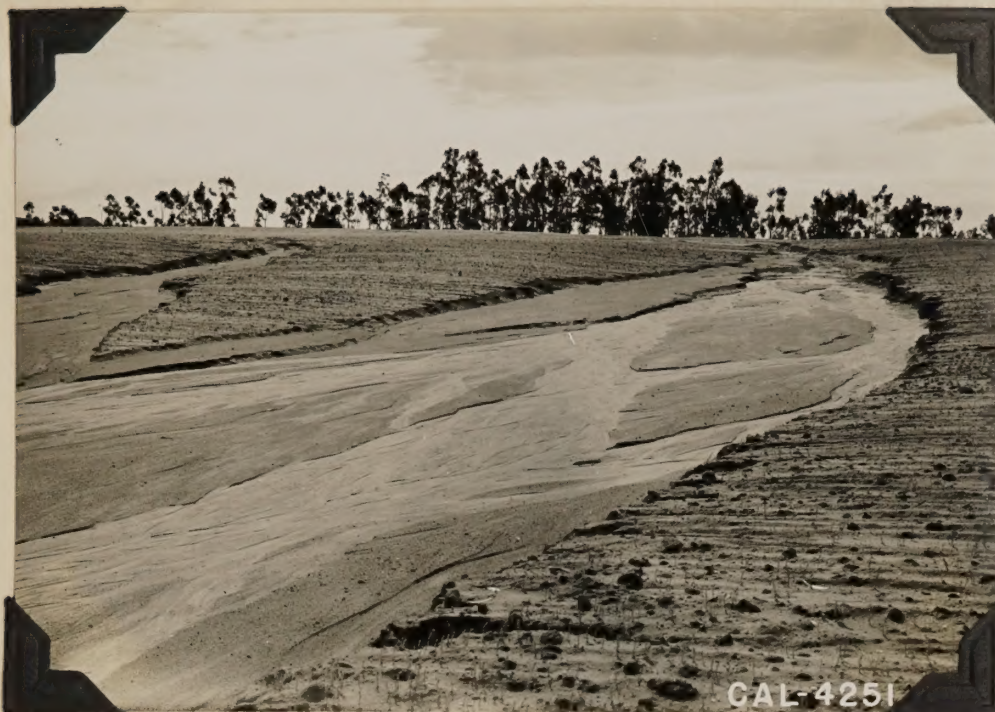
CAL-4251 - John Arneill property located in the Camarillo District. This property was planted to flax previous to the storm of March 2. Soil is a sandy loam lying on approximately a 1% slope. No erosion control measures on this farm. Washes and gullies created by March 2 storm on approximately 1/2 of 65-acre field. Estimated loss to growing crop, 65%. Thousands of tons of deposition were washed across the State Highway and deposited in valuable orange groves below which were controlled completely with a fine winter growing cover crop.

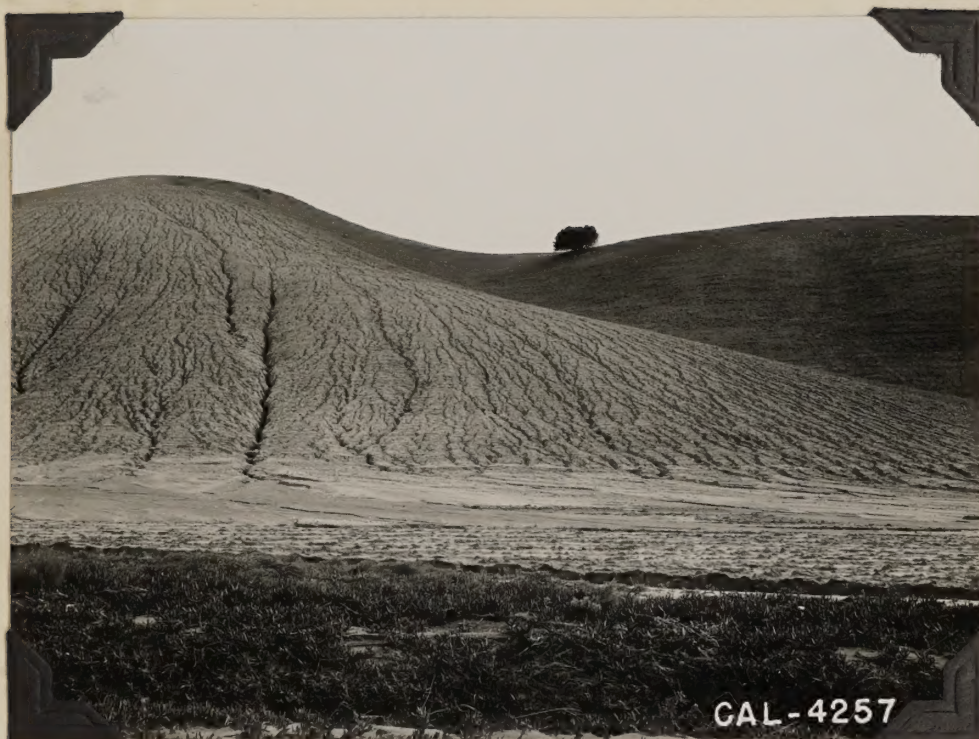
CAL-4257 - Glenn Property. Striking example of clean-cultivated land continuously farmed to beans year after year. Shows comparison between the hill in the foreground which was clean-cultivated and the hill in the background which had been retired two years, 1935 and 1936.

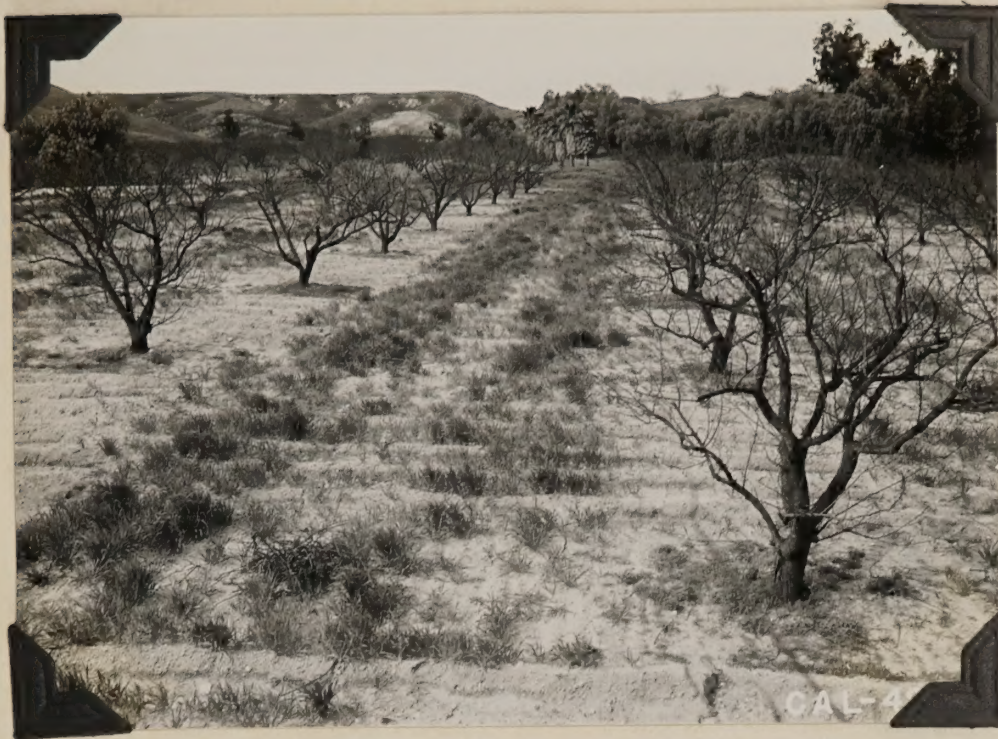
CAL-4253 - Mose Waters' Ranch. This 100-acre apricot grove is dry-farmed and prior to this year has been clean-cultivated during the winter months. Property under cooperative agreement at present and erosion being controlled with basin-listing and cover cropping. To date, 17 and 1/2 inches of rain have fallen on this orchard, including the rain of March 2.

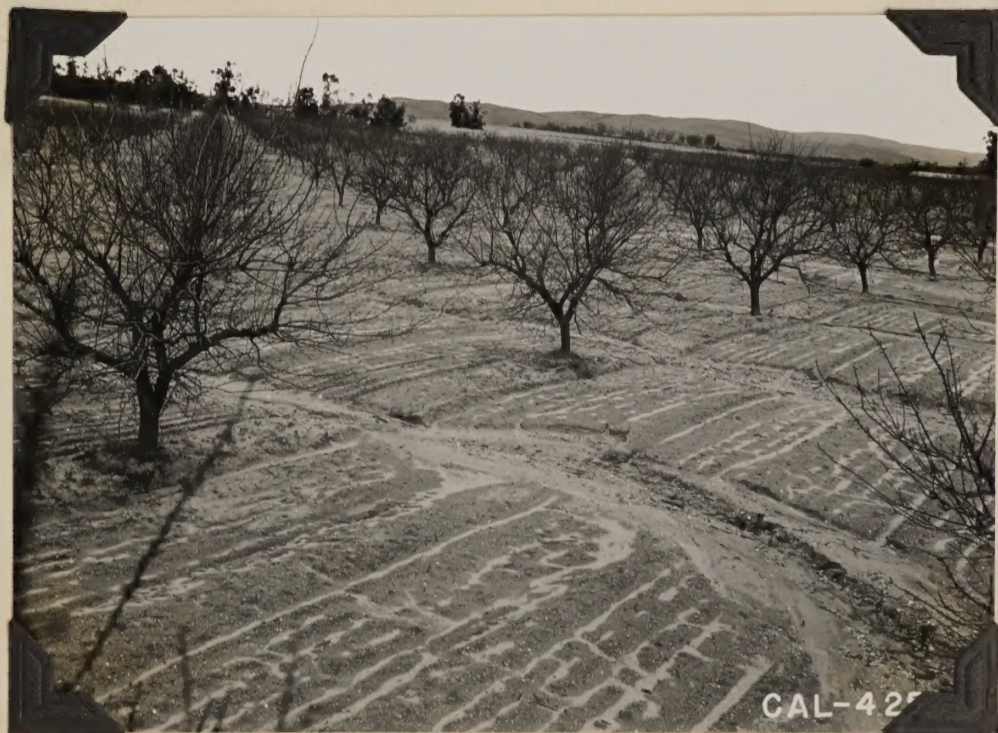
CAL-4252 - Harris Hitch Ranch. This orchard lies immediately adjacent to the Waters' property. Shows soil washes and losses where no erosion control methods have been taken. Formerly, all apricot groves in this district were farmed in this manner.

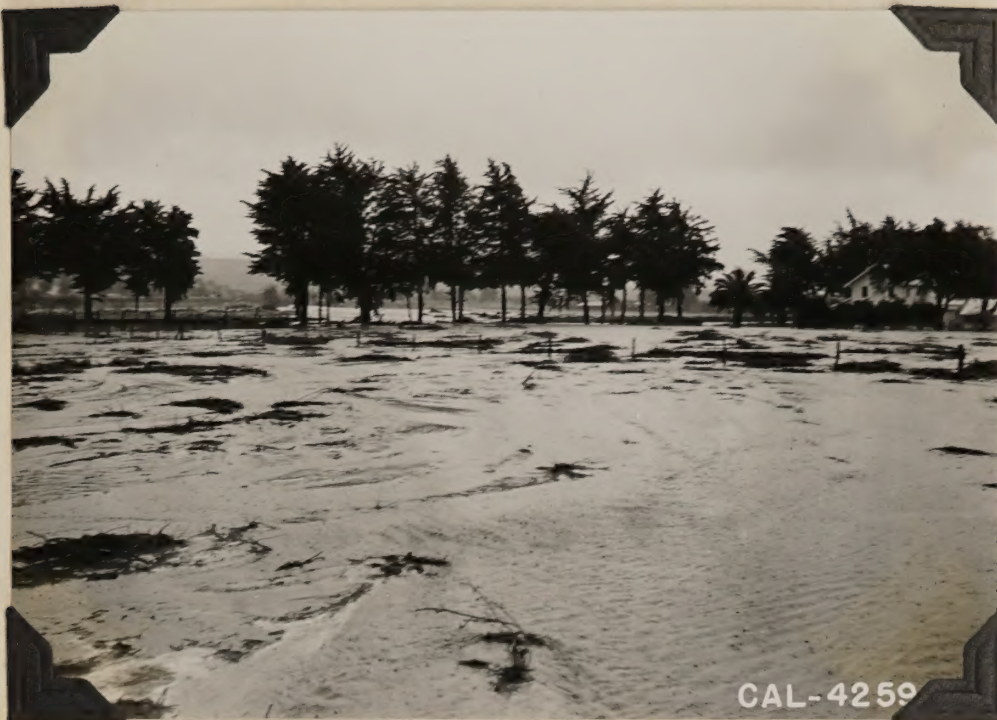
CAL-4259 - James Hitch property. View of water and sand flowing across a ranch, off the Las Posas Area, during the storm of March 2. This picture was taken from a wagon standing in the field. Later, the wagon was nearly covered with silt and debris from the water flowing in the foreground.

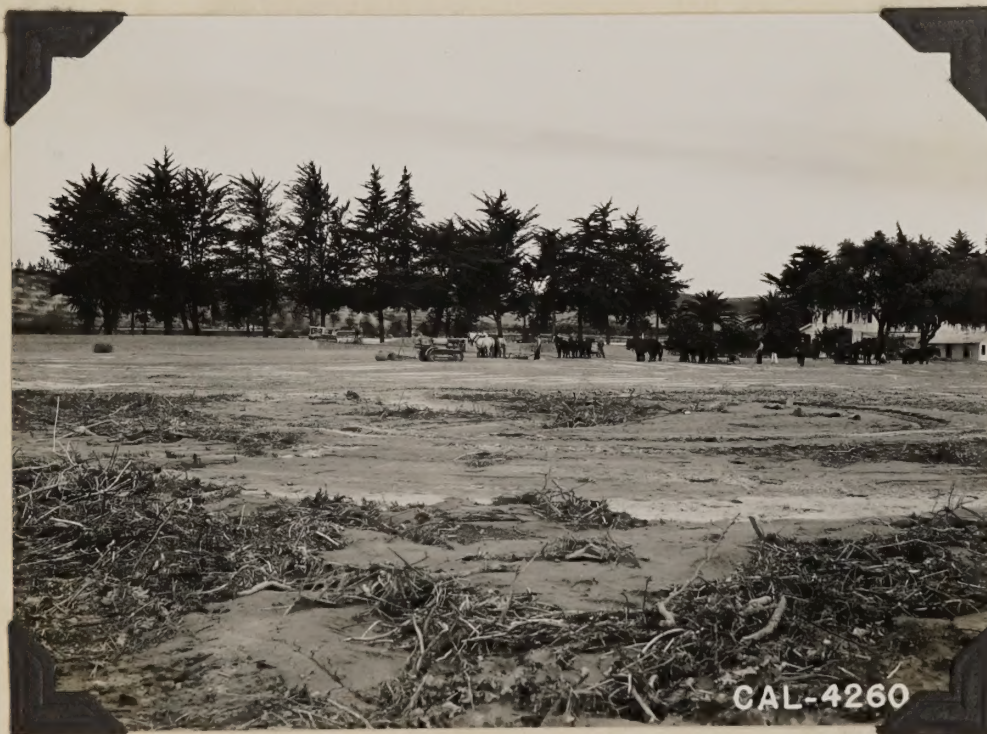
CAL-4260 - James Hitch property. Same view as adjoining picture but photographed on March 10. Shows condition of field after flood waters had subsided. Beginning April 1, this field is to be planted to Valencia oranges. Owner estimates cost of removing sand from field at \$250 an acre. Stock and equipment shown in picture are being used to clear the field and prepare it for the planting of oranges.

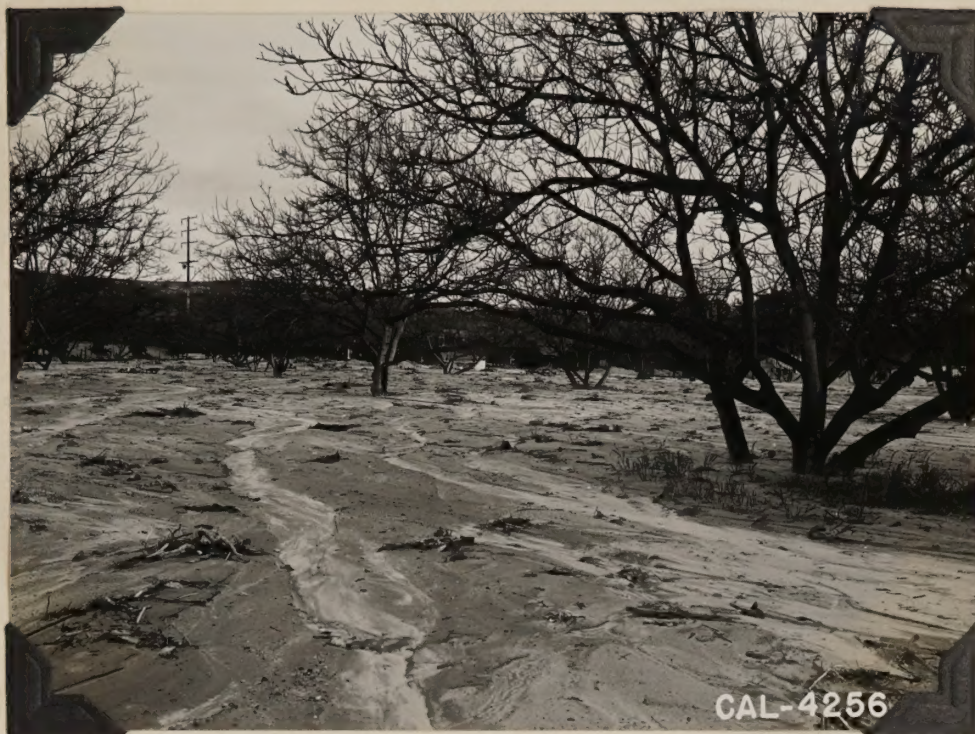
CAL-4256 - Hoffelt Property. Showing 33 year old English walnut grove, 9 acres in area, being covered by deposition from clean-cultivated bean land two miles distant. Measurements were taken of the deposition and the average depth was estimated as 3 feet. This deposition varies from a few inches on one part of the orchard to as much as six feet in the deepest parts. Owner considers both orchard and land a total loss.

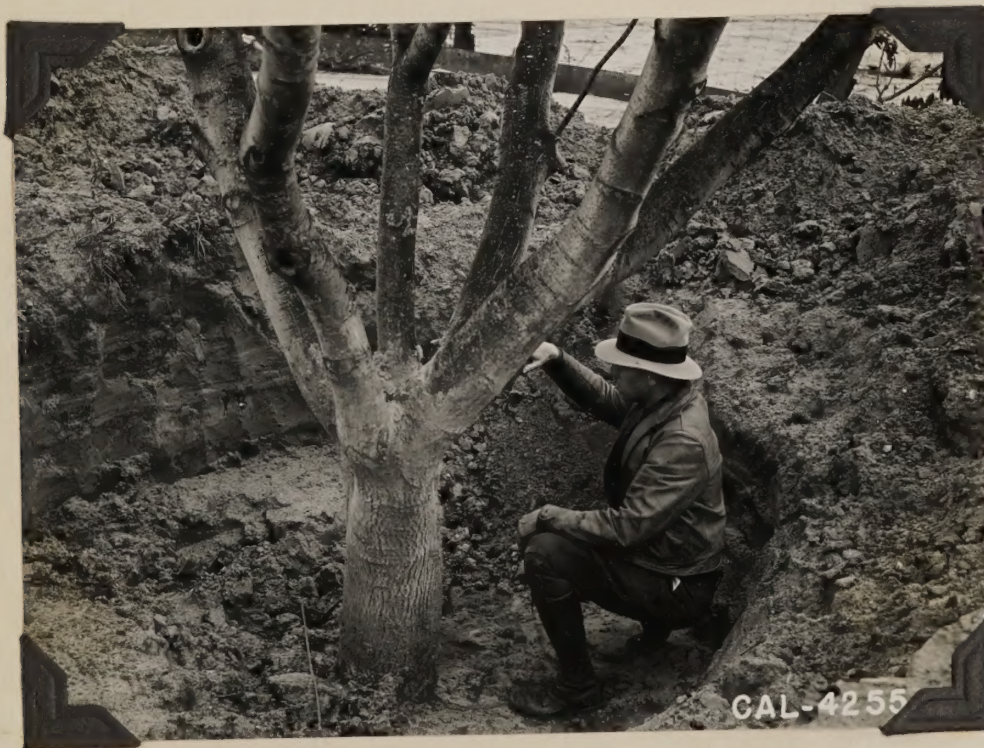
CAL-4255 - Hoffelt property. Showing depth of deposition around 33 year old English walnut tree. Banks of excavation are of pure sand with no agricultural qualities whatever.

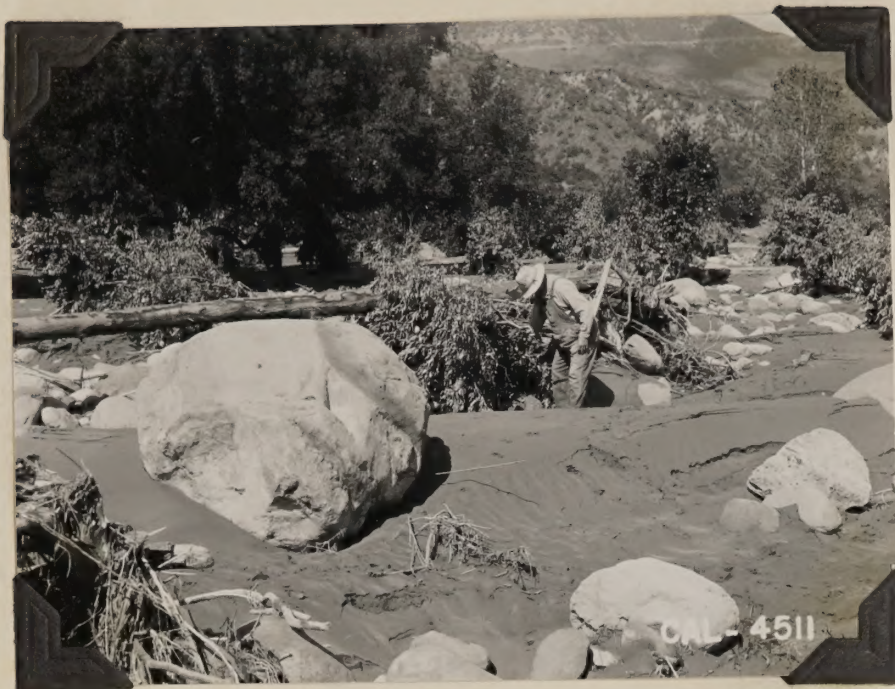
CAL-4511 - Citrus orchard damaged by deposition of silt and rocks on delta cone of mountain canyon. Note size of boulders transported by the flood.

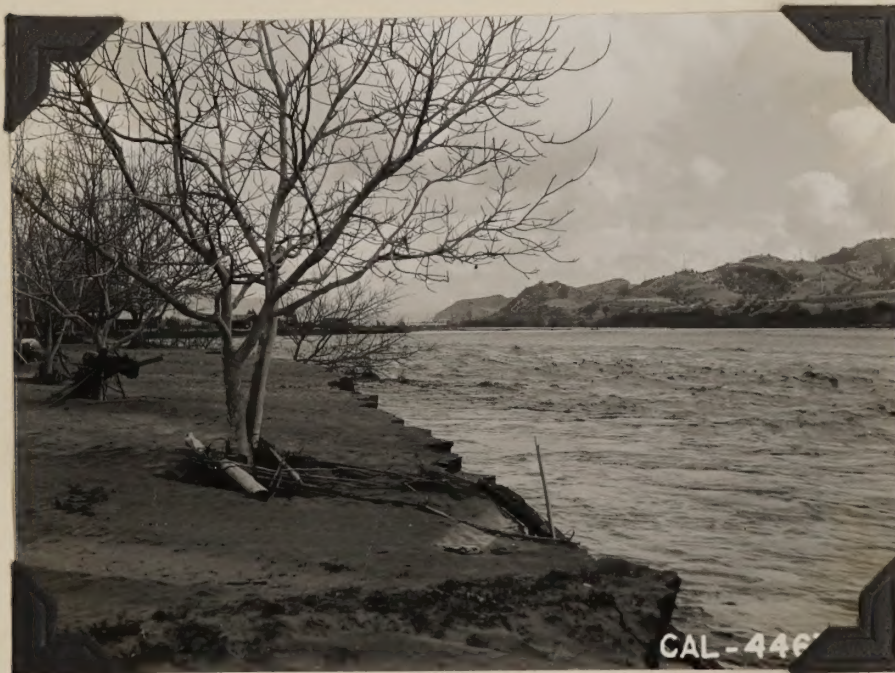
CAL-4463 - Santa Clara River at Santa Paula, California, at flood stage showing typical bank erosion. Walnut trees being undermined and falling into the stream.

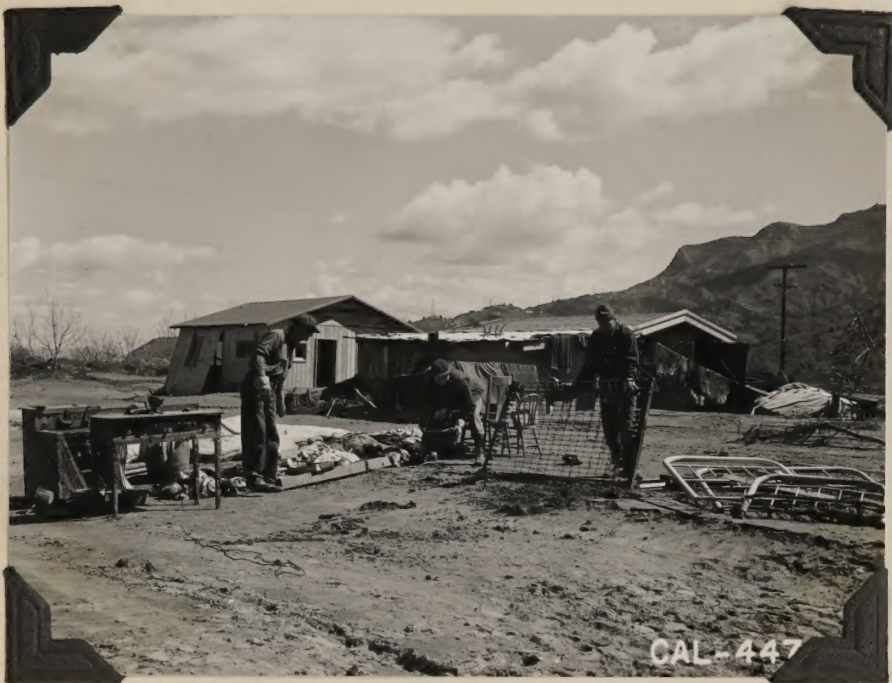
CAL-4475 - Destruction of homes by flood water from Santa Clara River.

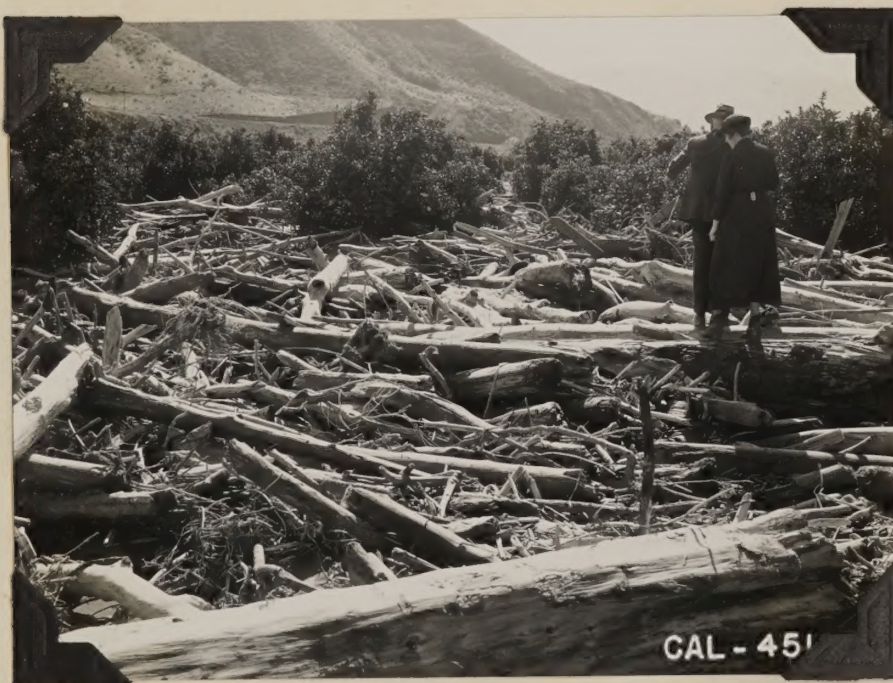
CAL-4510 - Citrus orchard near Ontario, California, showing deposition of drift at the mouth of a canyon.

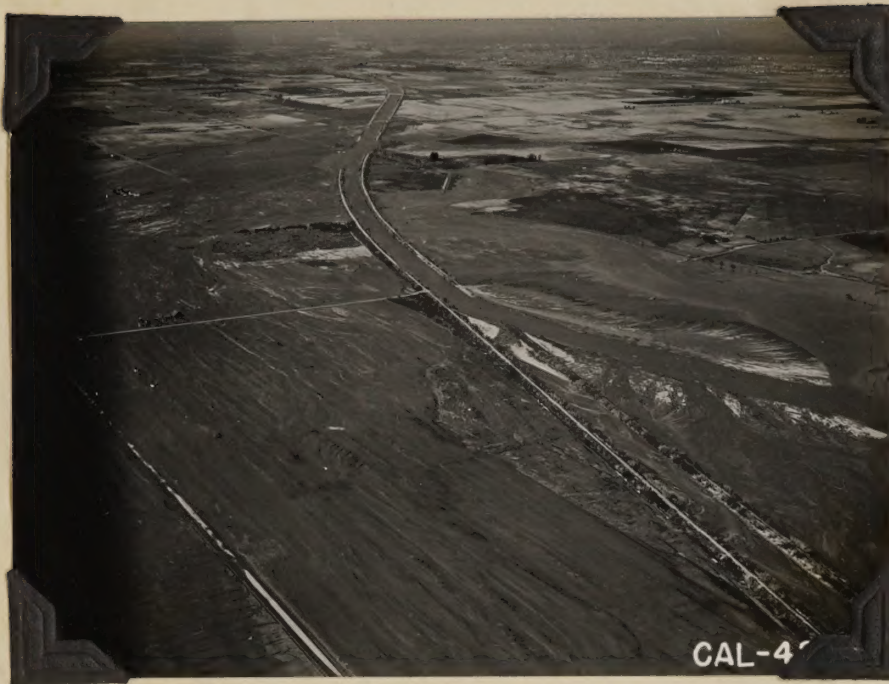
CAL-4293 - Flood waters of the Santa Ana River breaking out from the improved channel of inadequate size.

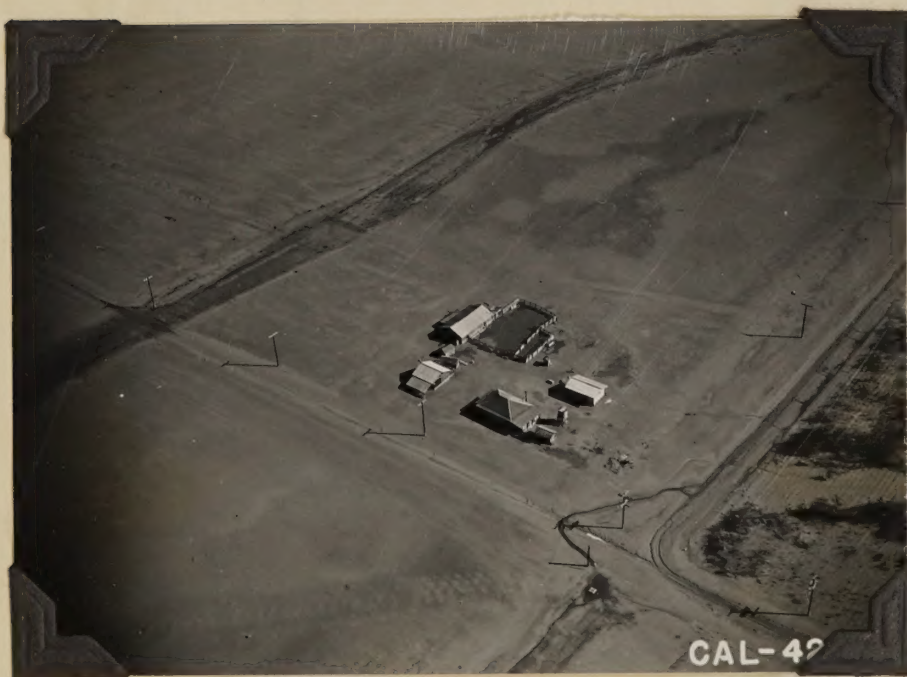
CAL-4295 - After the flood has passed. Agricultural land covered by sand and silt.

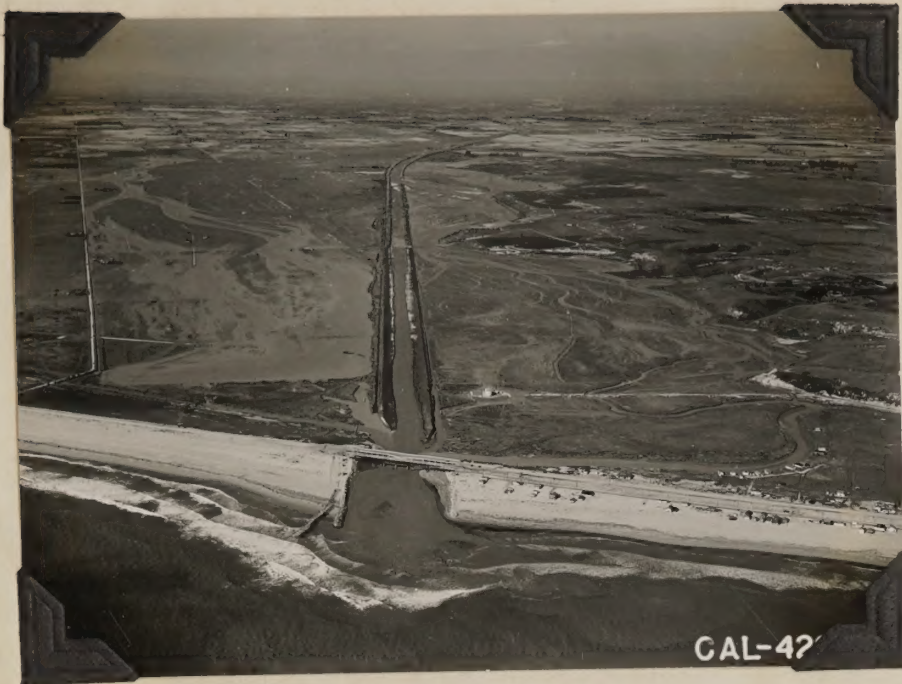
CAL-1291 - Santa Ana River showing improved channel and adjacent area covered by flood water because of inadequate size of channel. Mouth of channel in foreground.

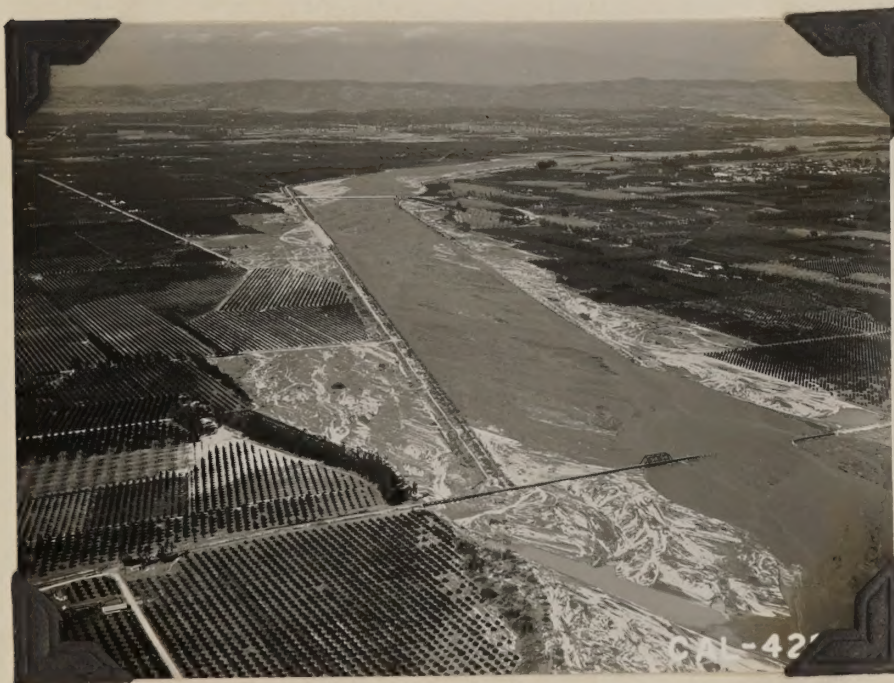
CAL-1299 - Santa Ana River, east of Anaheim, showing character of agricultural development that was damaged by flood waters. Damaged railroad bridge in foreground.

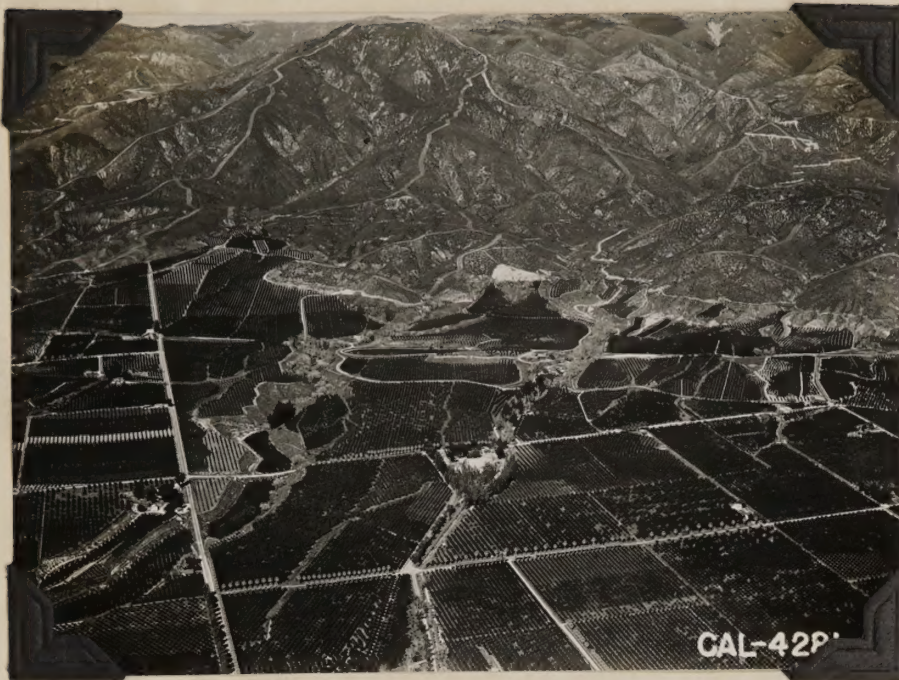
CAL-4281 - Flood channels from steep mountain canyons spreading over highly improved agricultural land in San Bernardino County.

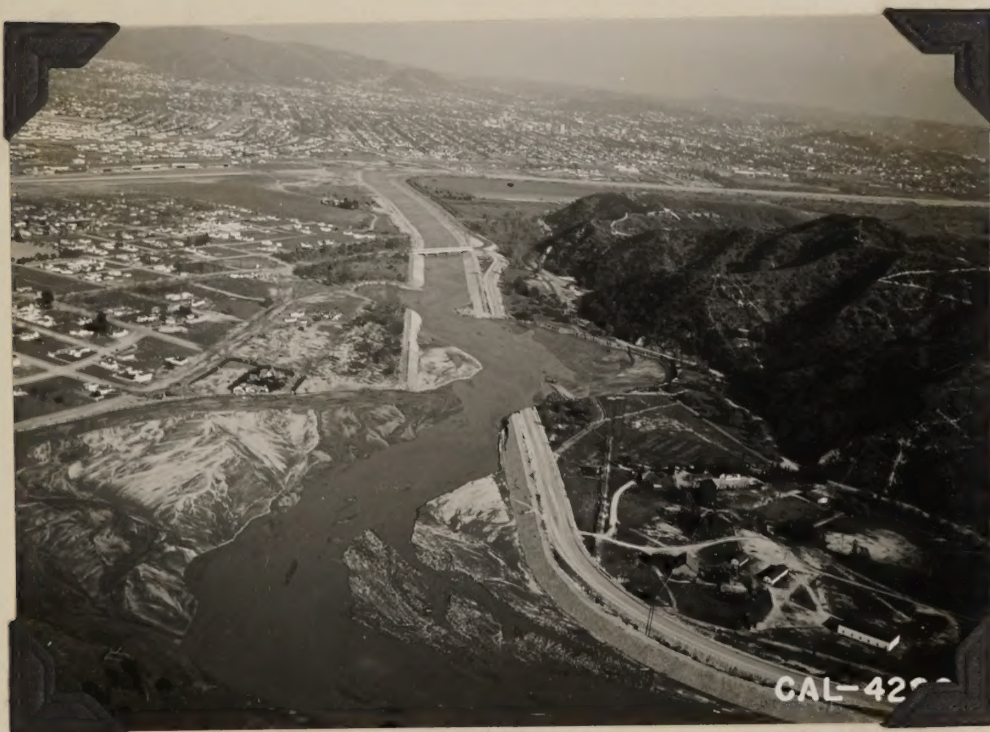
CAL-4299 - Los Angeles River at Griffith Park showing rock-revetted embankments destroyed by the flood.

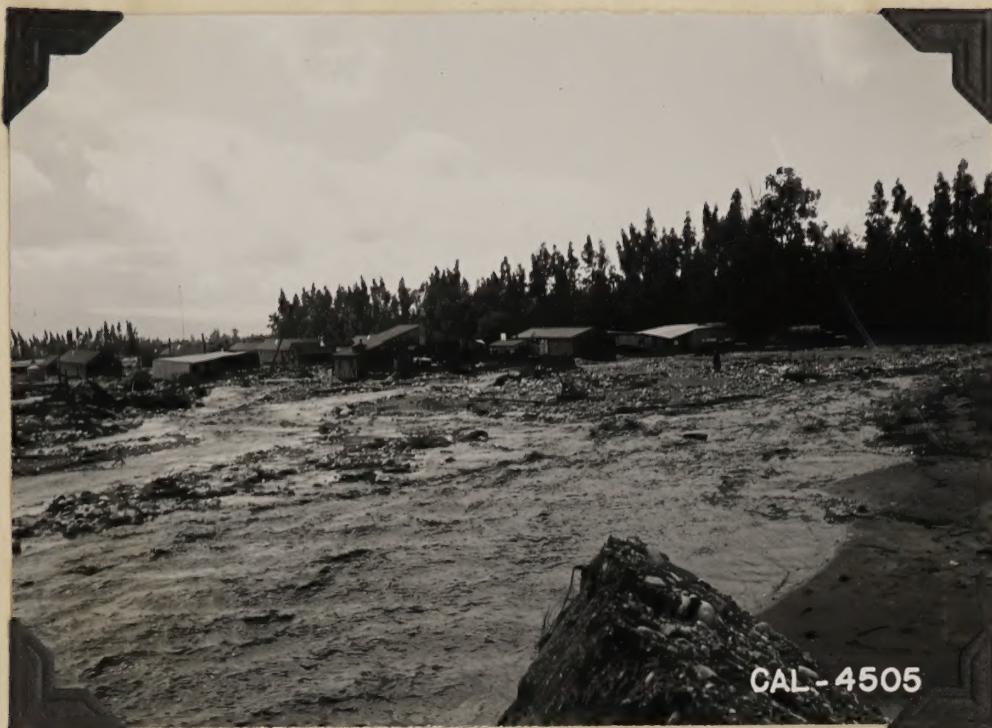
CAL-4505 - Cucamonga CCC Camp, Cal-10, damaged by overflow from Cucamonga Creek.

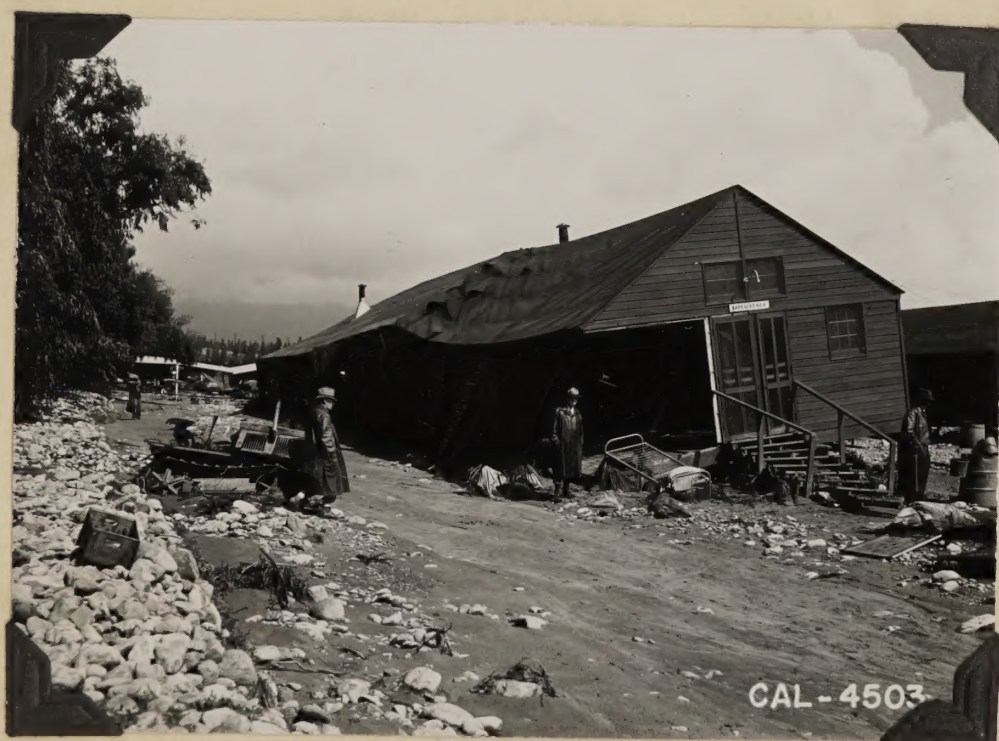
CAL-4503 - Cucamonga CCC Camp damaged barrack.

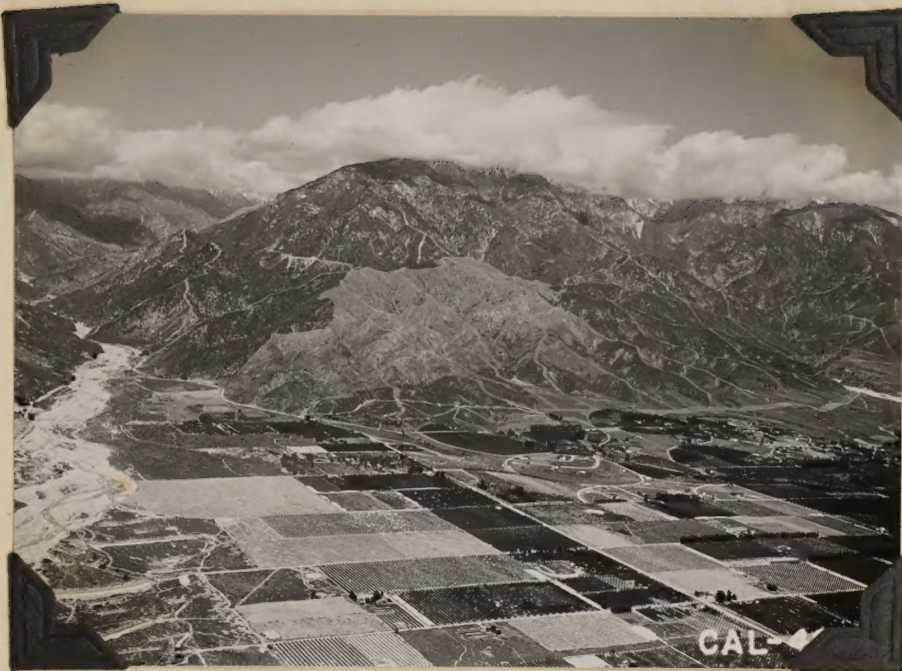
CAL-4275 - Typical mountain terrain in southern California showing flood from canyon and highly developed agriculture on delta cone.

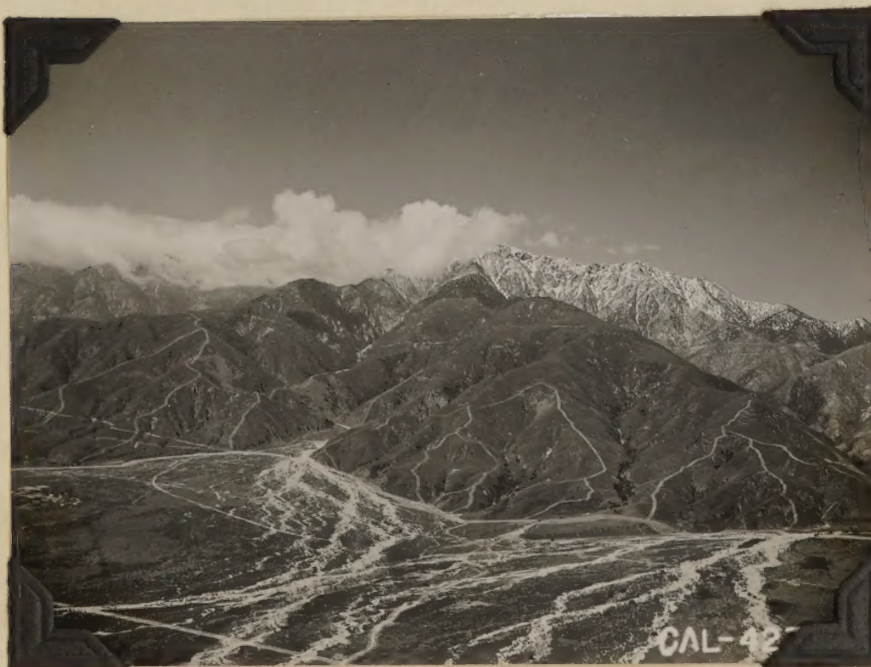
CAL-4279 - Flood waters from steep canyons spreading over delta cones.

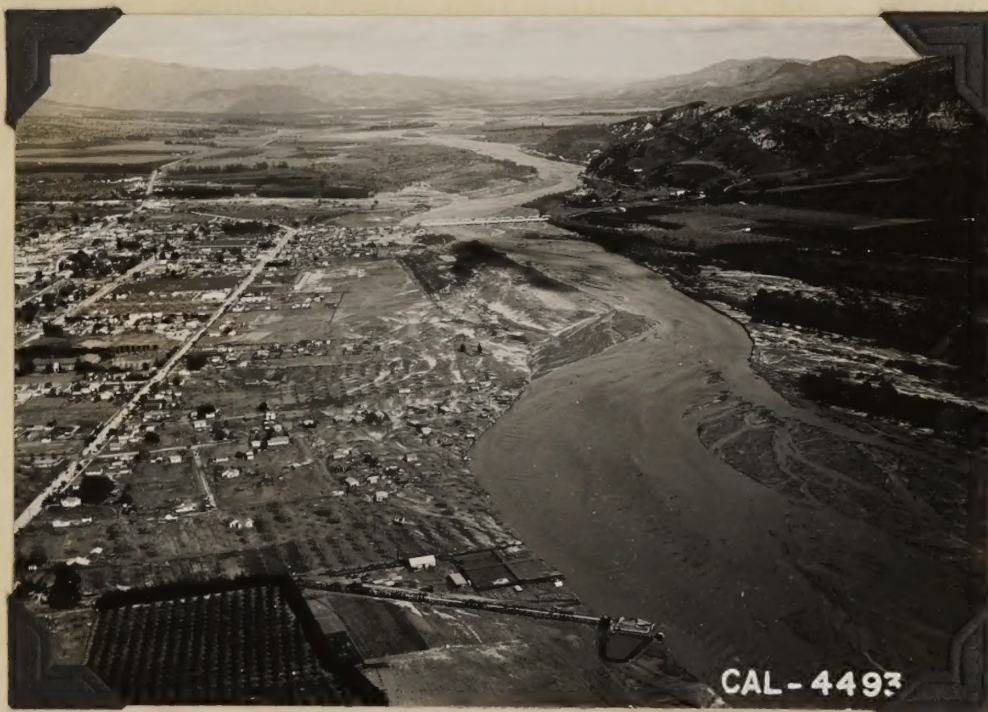
CAL-4493 - Flood flow in the Santa Clara River at Santa Paula, California showing residences being flooded. The Soil Conservation Service Nursery lath house in middle foreground being destroyed by bank erosion. The river at this point widened its channel about one-quarter of a mile by bank erosion.

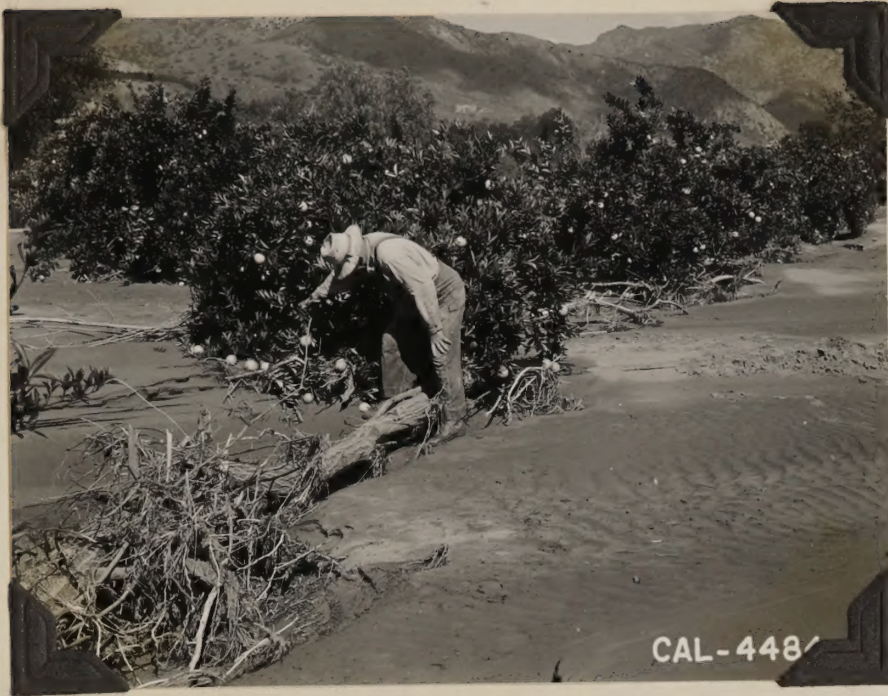
CAL-448 - Citrus orchard damaged by deposition of two feet of sand and silt.

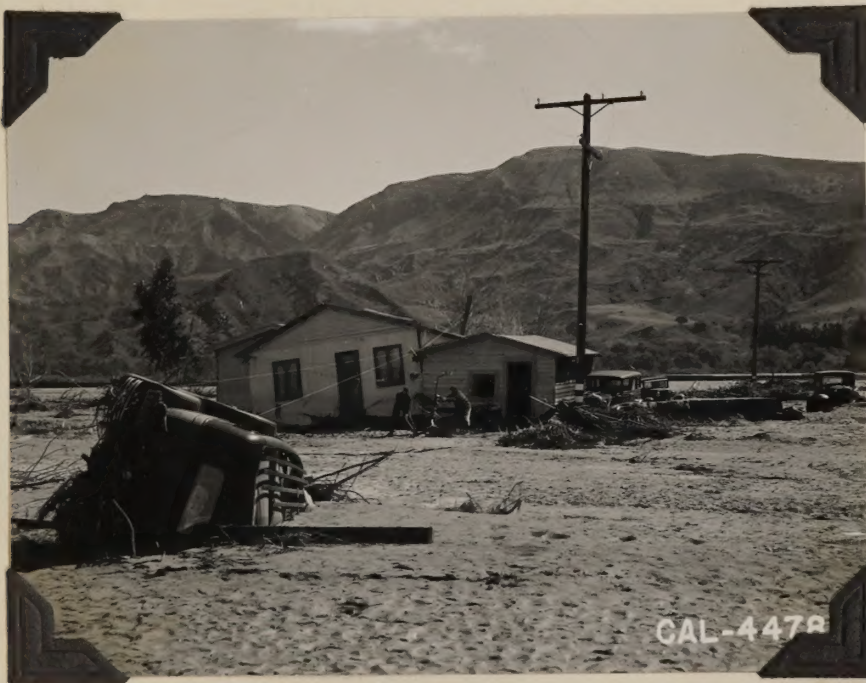
CAL-447 - Destruction of homes by flood water from Santa Clara River.

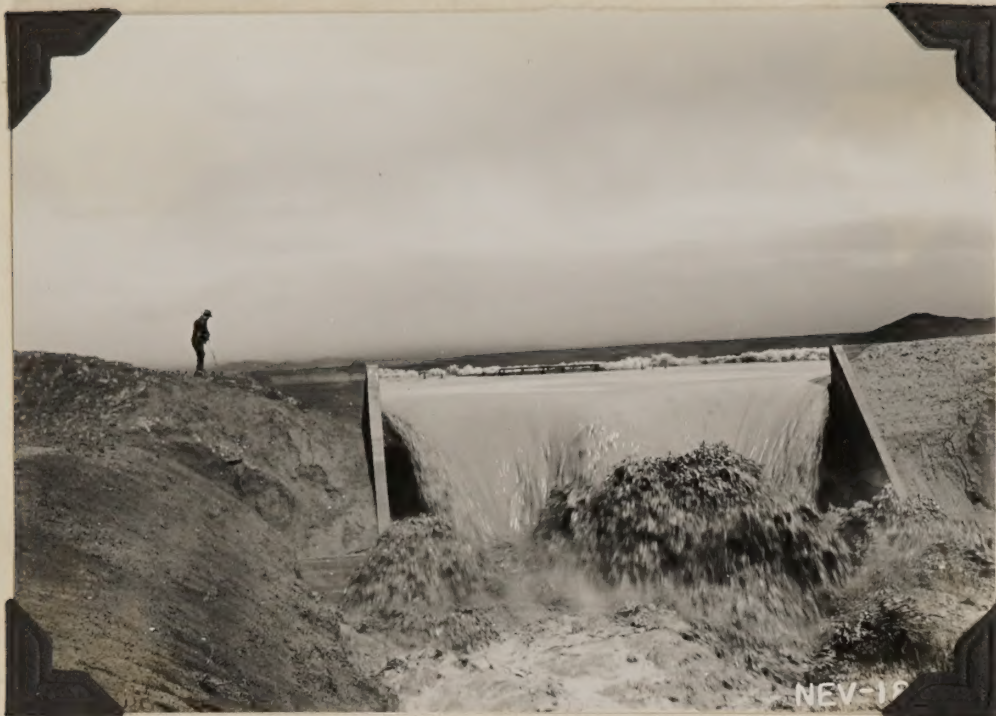
NEV-184 - Flood waters of Meadow Valley Wash going over a 16 foot drop installed by the Soil Conservation Service to control head cutting.

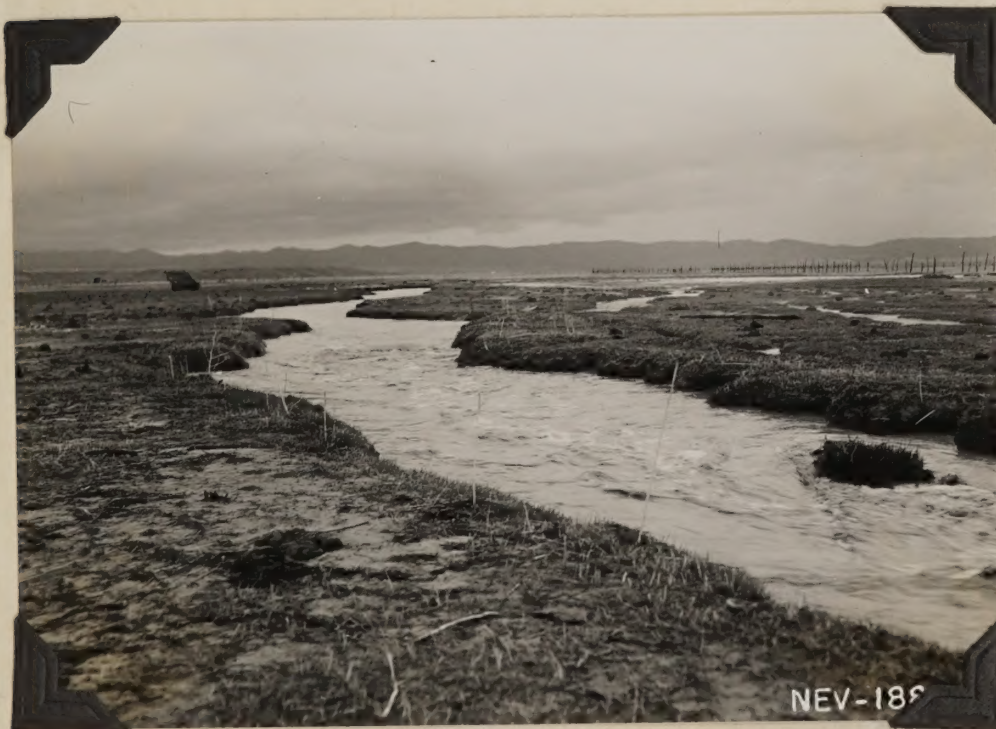
NEV-185 - Meadow Valley Wash showing normal condition above the 16 foot head control drop installed by the Soil Conservation Service.

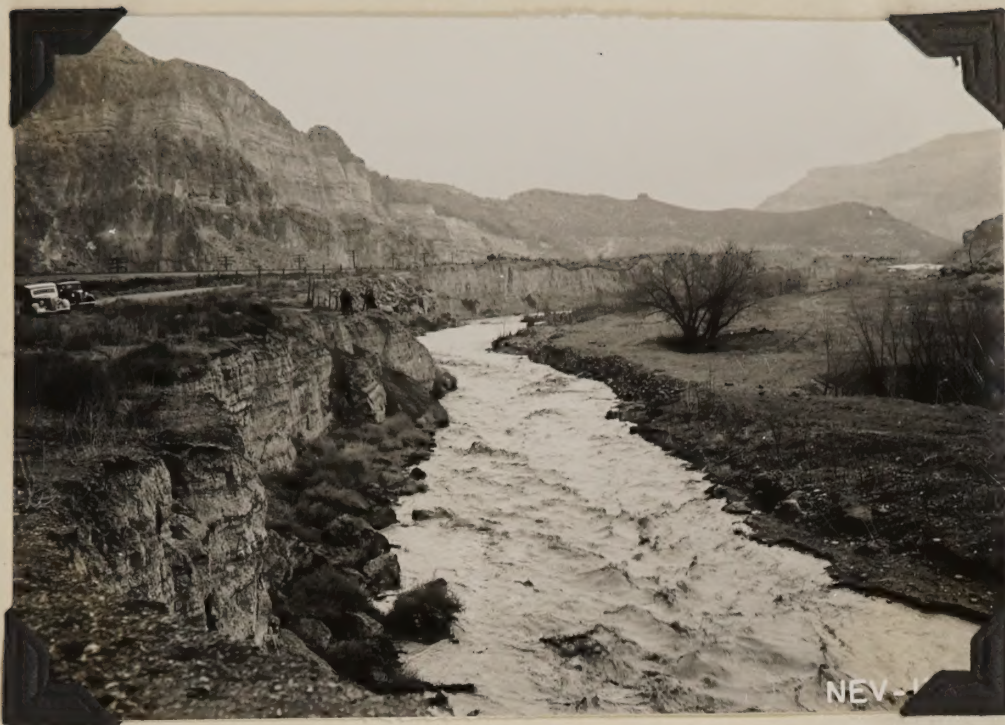
NEV-277 - Meadow Valley Wash entrenching its channel in a narrow valley.

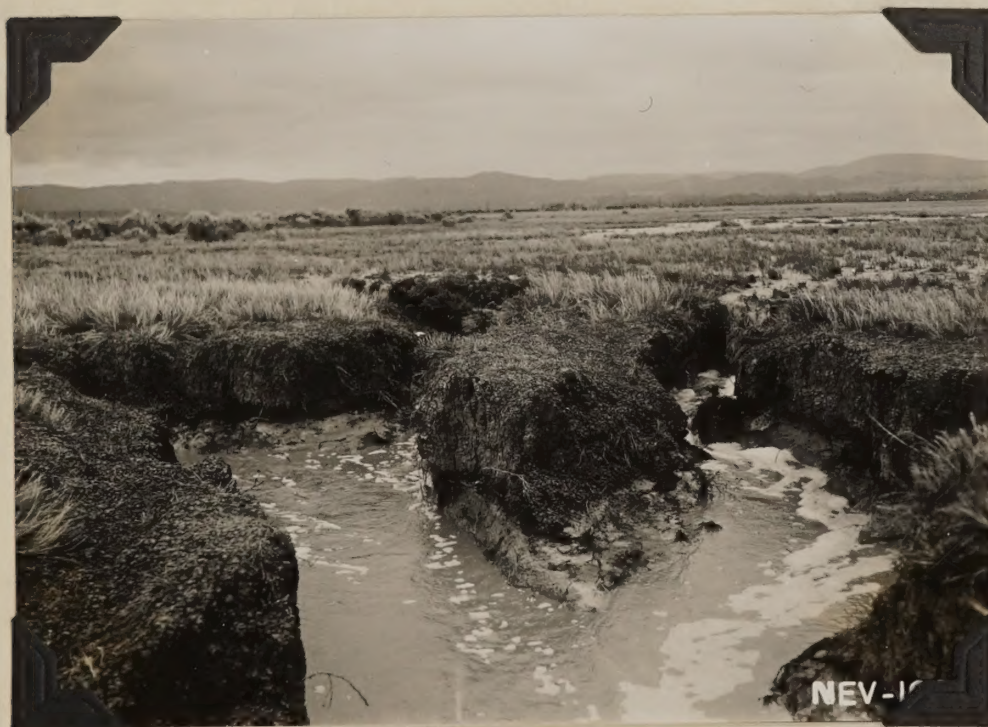
NEV-168 - Meadow Valley Wash an unprotected head cutting in a meadow valley.

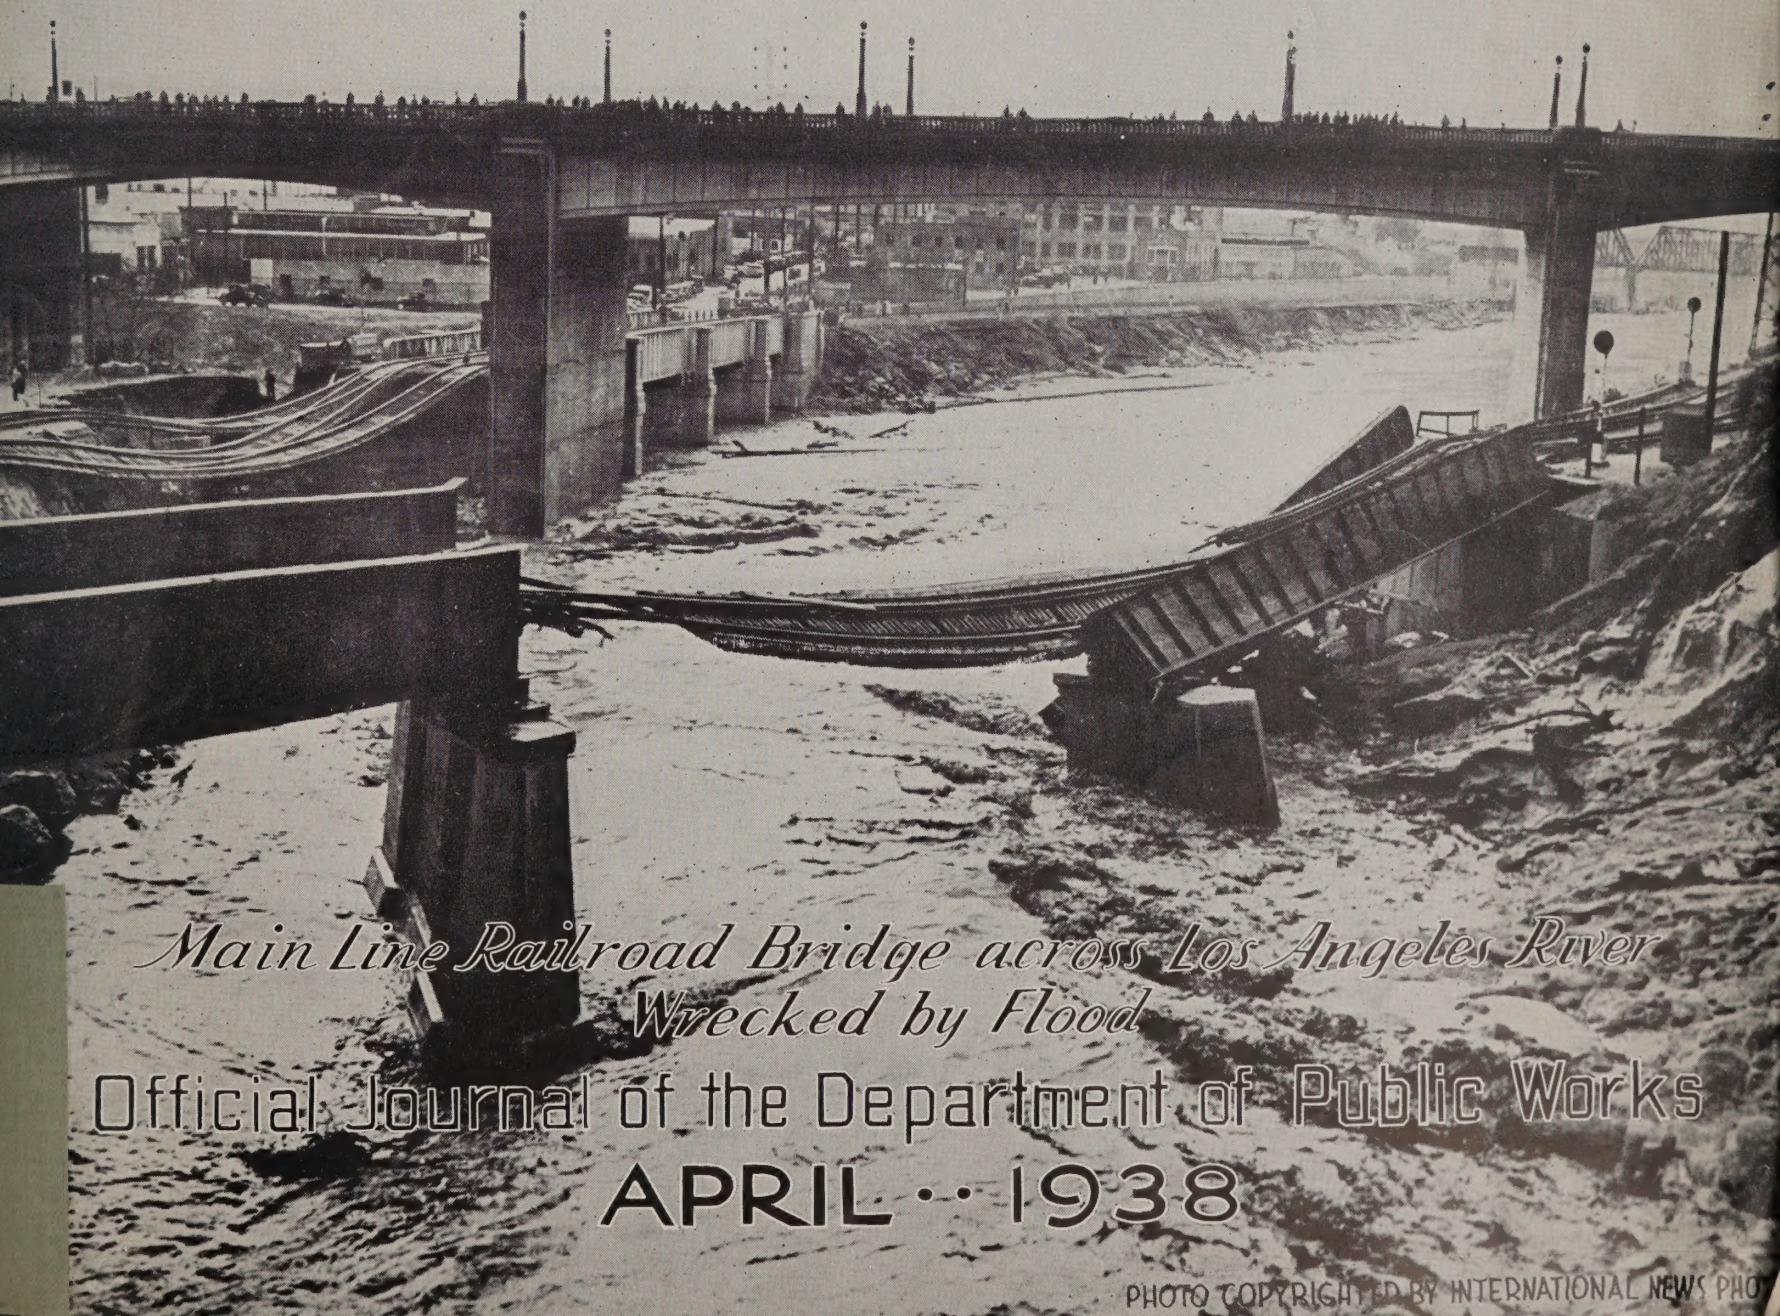
*Main Line Railroad Bridge across Los Angeles River  
Wrecked by Flood*
